# Acequia de Santa Cruz

**Location:** The Acequia de Santa Cruz is located in the center of Espanola, NM.

**Operating Unit:** The Acequia de Santa Cruz is approximately 4.5 miles in length.

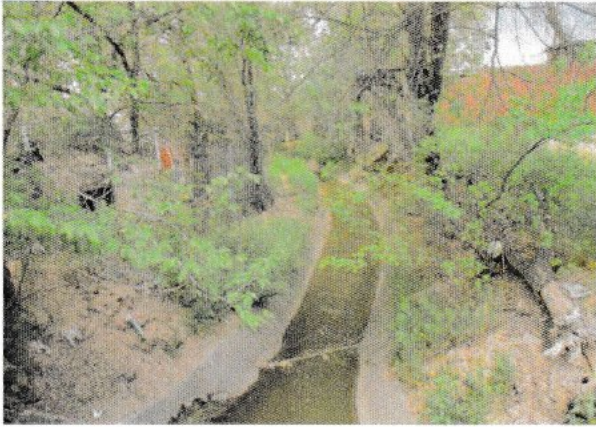
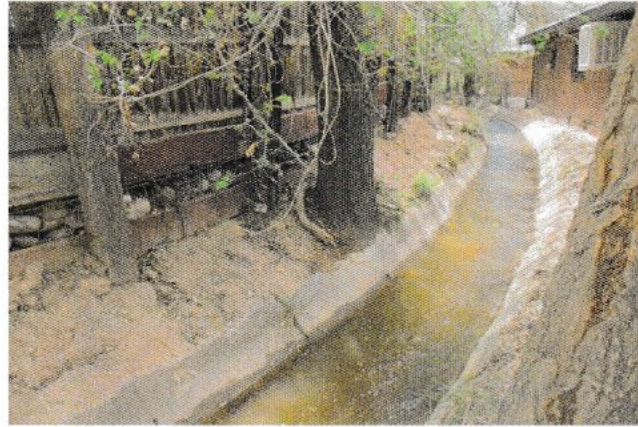
*The images above depict areas of The Acequia de Santa Cruz that have been lined with concrete walls to prevent erosion, reduce the amount of water lost to surrounding vegetation and ensure the allocation of water per irrigator. Minor damage to the design has developed and future maintenance should be considered to ensure the workmanship of the Acequia.*

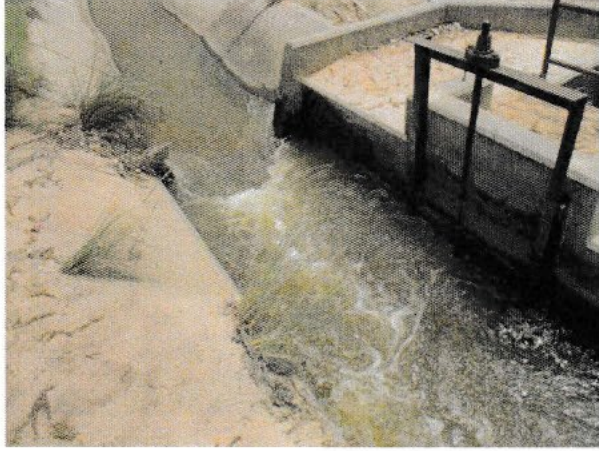
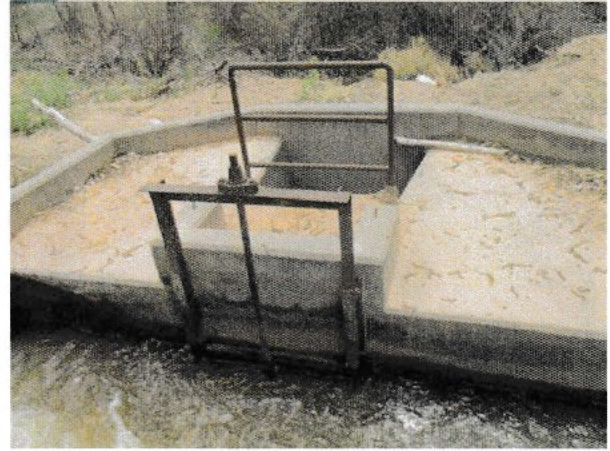
*The combination structure above facilitates a rapid change in elevation and is engineered to prevent the occurrence of erosion by implementing a composite of concrete. The infrastructure also has a check-gate to divert the accumulated sediment and ensure the efficiency of water flow.*

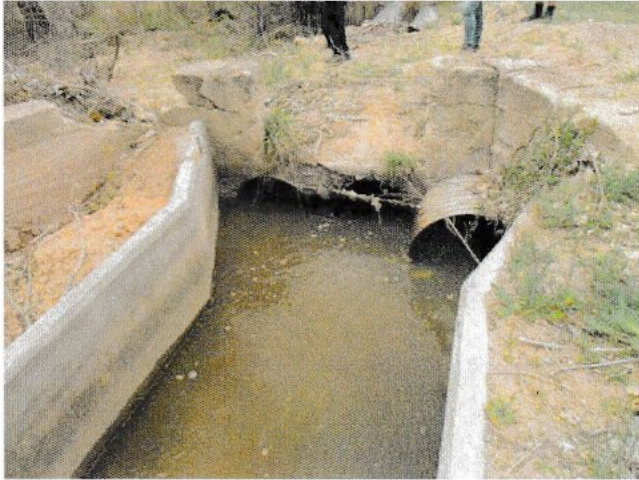
Waypoint 405

*The first photo taken at waypoint 405 depicts irrigation water traveling through three underground culverts. Debris has enabled the movement of water flow in the middle culvert. Waypoint 406, shows the damage that has occurred and is causing leakage within the first culvert. All three culverts are approximately 70 feet in length and are in need of replacement.*
